SUBSEA FLOODED MEMBER DETECTION

FLOODED MEMBER DETECTION BY GAMMA SOURCE ALLOWS FOR SUBSEA MEMBERS TO BE INSPECTED FOR FLOODING AS A RESULT OF CRACKING, DAMAGE, CORROSION OR WELD DEFECT, WITHOUT THE NEED FOR THE HIGH LEVELS OF CLEANING REQUIRED BY OTHER METHODOLOGIES. AS SUCH, A MORE TAILORED INSPECTION PLAN CAN BE PREPARED FOR MORE DETAILED INVESTIGATION AS WELL AS OTHER INSPECTION TASKS AND TECHNIQUES.

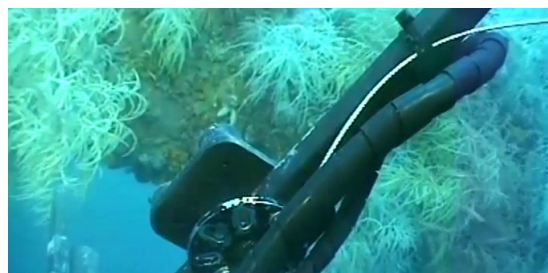
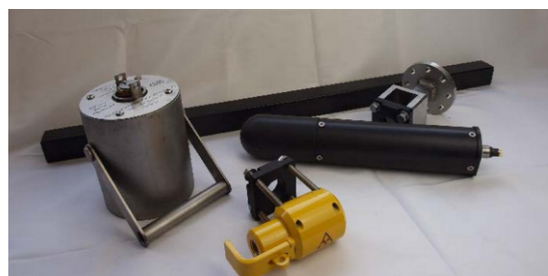
The PMAC ROV-mounted FMD apparatus uses a small radioactive source mounted in a collimator and a scintillating crystal detector pod obtaining a result from a member in a matter of seconds. The system is controlled by a proprietary software system allowing the user to measure, store and report in an integrated package. The FMD software logs and analyses all relevant data, recording it quickly and efficiently for production of a report within hours of completing a workscope and highlight anomalies within minutes to client.

The system in normal mode can determine whether a member is dry or flooded with great accuracy. Reliability of the results allows checks to be carried out quickly. The FMD frame is of modular construction to facilitate fast, flexible and convenient frame configuration. Fabricated from steel and acetal sections with hard anodised aluminium and stainless steel fittings with additional buoyancy being supplied. The design of the system permits inspection of members with diameters from 150mm to 3000 mm (this may be extended dependent upon the capabilities of the host ROV) and wall thickness of up to 60mm, dependant on the diameter/WT combination to be tested.
